KN15D-2

15L BACKPACK SPRAYER

SERVKN15D-2 REV B - 17/10/2025

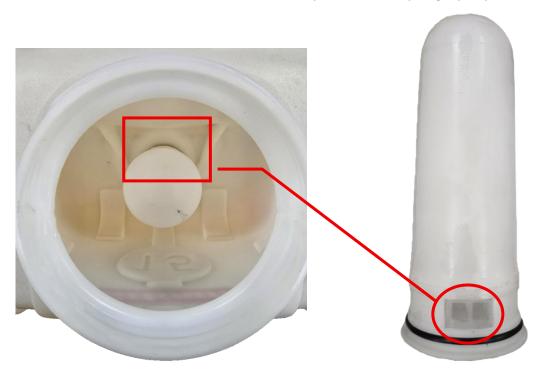
d. Built-in mesh film. Please refer **Section 4.** to safely detach the diaphragm pump to check.

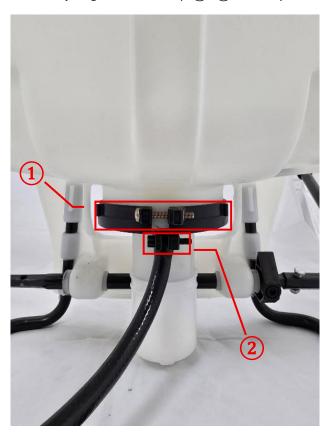
1.2 Pump leaking at tank connection

Leaking may be caused by:

a. Loose connection clamp: Tighten the clamp (1), (2) securely.

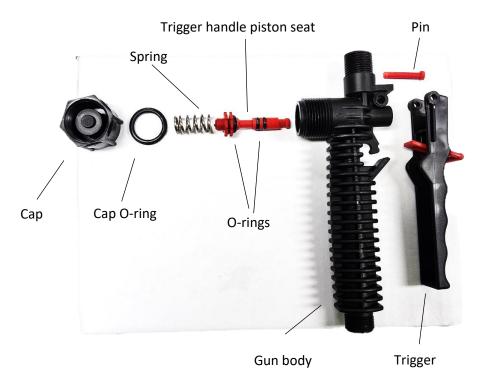
1.4 Spray gun does not shut off

- 1. Disconnect the spray gun from the spray lance and hose
- 2. Disassemble the spray gun
 - i. Carefully remove the pin from the gun body and trigger
 - ii. Remove the trigger
 - iii. Unscrew the cap
 - iv. Push the trigger handle piston seat out of the gun body

3. Check O-rings on the trigger handle piston seat for swelling, damage, missing parts or blockages.

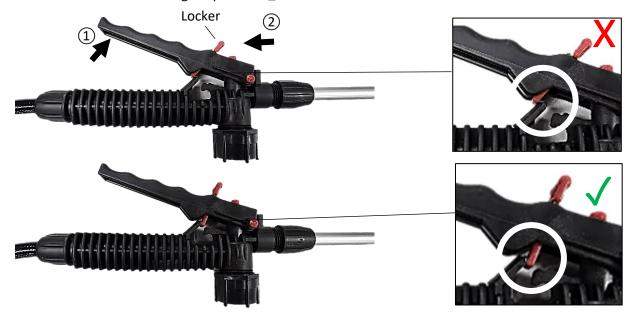
1.5 Trigger does not lock on

If the locker is offset, gently push the end of the trigger outward 1 and realign the locking mechanism inward to its original position 2.

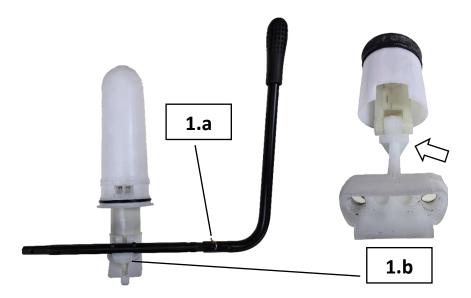
- a. **Check the R-pin**: Ensure the R-pin is properly positioned. It must securely connect the pump handle to the shaft. If the R-pin is missing or out of alignment, the handle will not engage the pump mechanism.
- b. **Inspect the piston hinge**: Pull the piston out of the pump chamber. Check the hinge at base of the piston for any looseness, wear or damage.

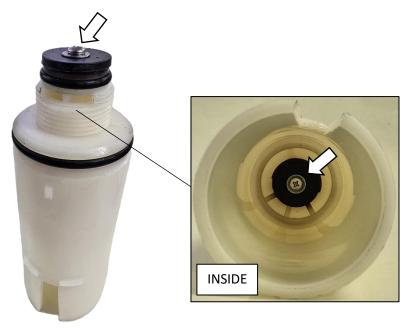
b. **Rubber valves**: There are two screws securing the internal rubber valves, one is located at the top of the piston chamber, and the other is located inside the chamber. Remove both screws to access the valves.

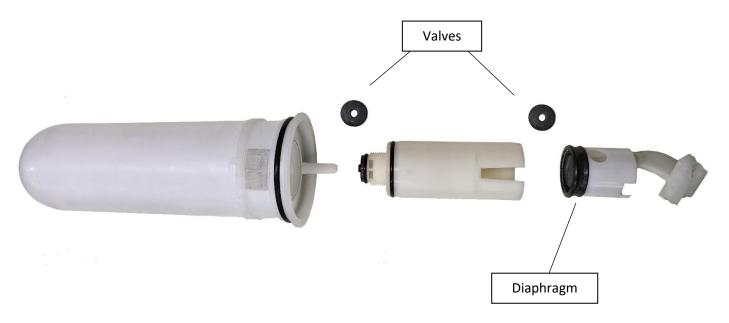
c. **Inspect the Diaphragm and valves**: Check all rubber sealing components for signs of wear, damage or cracking.

For Diaphragm replacement, use Silvan spare part kit: **KN15-1-1**.

For Valve replacement, use Silvan spare part: KN15D-1-4.

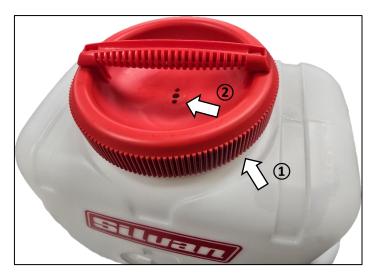
3.1 Lid leaking

If liquid is leaking from the lid area where it connects to the tank body, check the following possible causes:

The gasket inside the lid may be damaged, worn or misplaced. Ensure the gasket is position evenly in it groove before threading the lid onto the tank. Replace the lid if the gasket shows signs of cracking, flattening or wear.

Burrs may remain on the top edge of the tank during manufacturing, or the surface may be accidentally damaged during use. When the lid is tightened, the gasket may press against these burrs, creating gaps that allow leakage.

Inspect the tank rim for any rough spots or burrs and carefully remove them.

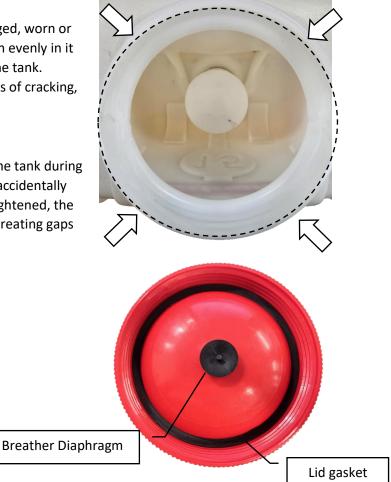
(2) Breather Diaphragm

The diaphragm located under lid may be worn, cracked or missing. Inspect the diaphragm ensure it is intact and seated correctly or not swollen by chemical attack.

Silvan spare part: Lid, 382-004

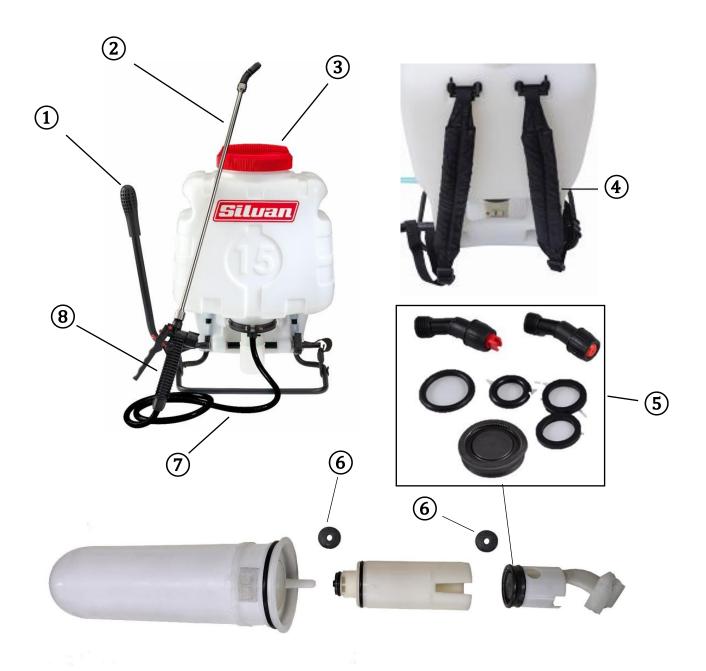
6. Carefully remove the diaphragm pump from the tank assembly.
